Piedmont Student Launch Team

2018 NASA Student Launch

Post Launch Assessment Review

April 27, 2018

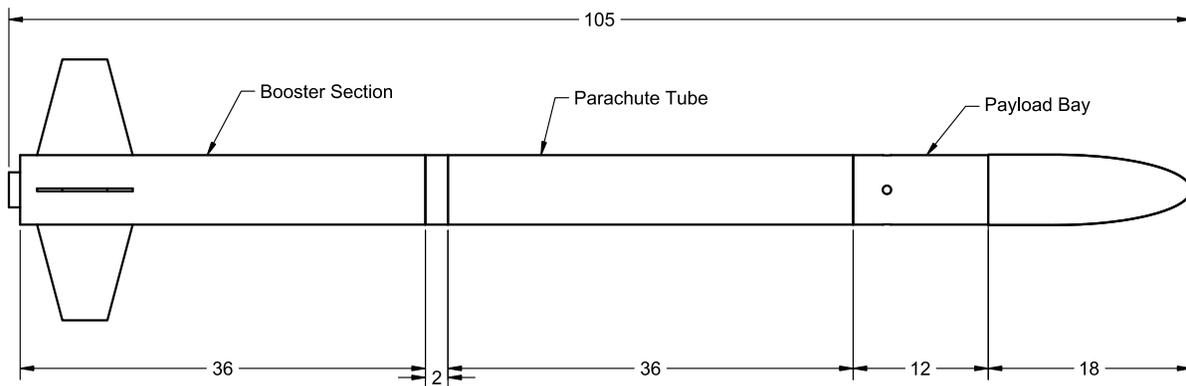
Figure 2.1 - Launch Vehicle Overview

The following table lists a few key features and dimensions of the launch vehicle along with some of the key results from the flight on launch day.

Feature / Result	Value
Diameter (in.)	6
Length (in.)	105.5
Motor	Aerotech L1420
Parachute diameter (ft)	16
Airframe material	Fiberglass
Fin material	Fiberglass
Apogee (ft)	3,938
Rail exit velocity (ft/s)	66.7
Maximum velocity (ft/s)	527
Drift (ft)	2,513
Maximum kinetic energy at landing (ft-lbf)	73

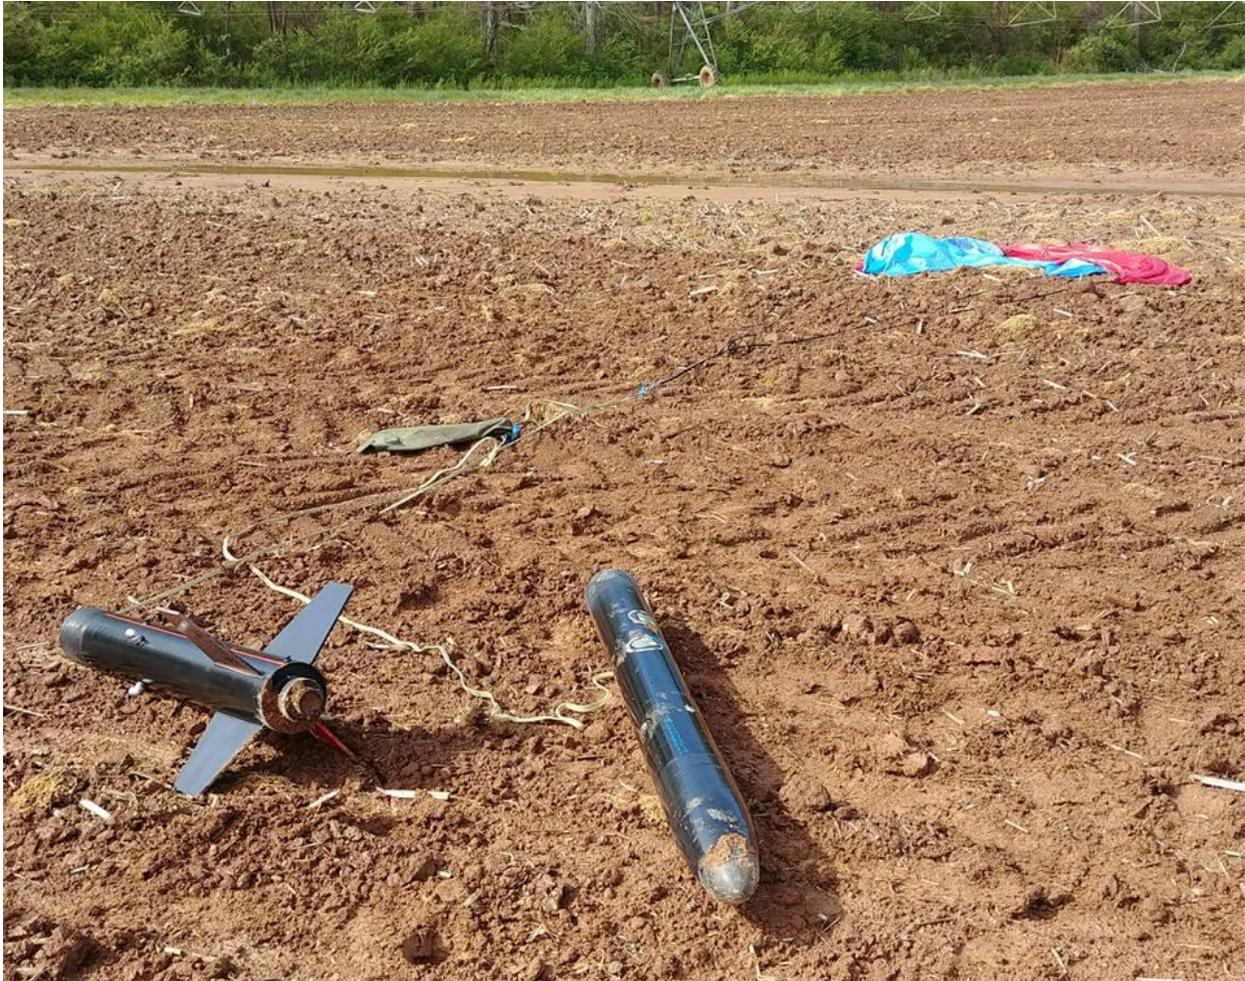
Figure 2.2 - Full-Scale at Landing

The rocket performed nominally from ignition to apogee. The recovery system electronics functioned properly, and the rocket separated smoothly at its apogee of 3,938 ft; however, the main parachute, which was meant to be held closed by a pair of Jolly Logic Chute Releases until 500 ft, pulled free from the Chute Releases, allowing it to fully deploy at apogee, subsequently causing the rocket to drift

significantly farther than it otherwise would have. Apart from that, the rocket landed successfully, and was recovered without any damage. Additionally, the tracker transmitted the rocket's position throughout the flight.

On the day of the launch, the rocket, *Stand Way Back*, reached an altitude of 3,938 ft; short of the target of 5,280 ft goal; however, it was within 20 ft of the apogee predicted as of the Flight Readiness Review. The rocket separated at apogee, as intended; although, the main parachute deployed early, causing the rocket to drift farther than anticipated. The rocket was ultimately recovered intact, albeit a bit muddy.

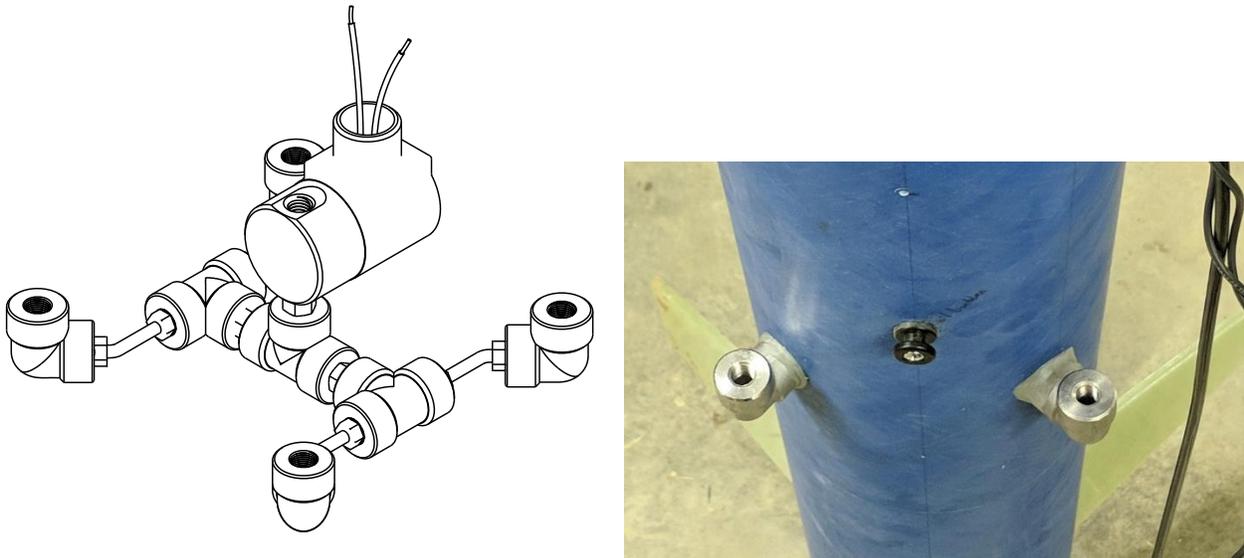
Figure 2.3 - ACS

The Altitude Control System (ACS) design featured a nitrogen tank filled to 2,100 psi. Once a controller determined that the launch vehicle needed to be slowed down, a solenoid would open, allowing propellant to travel to the four thrusters on the airframe. This would have slowed the launch vehicle down, reducing its apogee to reach the target of 5,280 ft. However, because the qualification flight of the rocket was done using a motor smaller than the full-scale motor flown in Huntsville, the ACS was not active during that flight, and so, for purposes of safety, was not active on the final flight. Additionally, because the system is only able to reduce the rocket's velocity, and not increase it, it is only able lower apogee, which was not necessary, as the predicted altitude was already below the target.

The reason for the lower altitude was a change in components used in the Altitude Control System. Several parts were replaced with equivalent parts with higher pressure ratings for safety purposes at CDR, but these parts were significantly heavier, reducing the final altitude.

The ACS, while novel and technically intriguing, did not prove to be as viable an option for adjusting the altitude as was originally thought; however, with further refinements, particularly including nozzles for the thrusters and a higher pressure for the propellant, the system may well provide a useful amount of control.

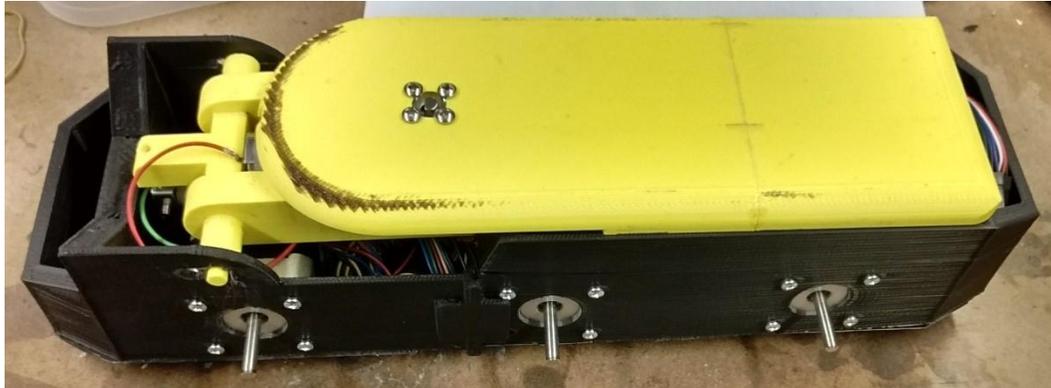
Figure 3.1 - Rover Body

The payload design consisted of a rover stowed within a 3D printed nosecone. The rover had six “infinity” wheels, designed to improve the rover’s ability to navigate difficult terrain, as well as a hinged arm that served as both the solar panel deployment mechanism and a righting mechanism.

While the rover was not flown, in testing, the components were successful. The wheels moved correctly, and the righting mechanism could deploy and had enough power to lever the rover into the correct orientation, albeit very slowly. Thus, a system that can help a disabled rover as well as this drivetrain design is feasible and can be successful.
